FUGRO CONSULTANTS LP

Report No. 0415-1622
January 12, 2007

Fault Delineation Study Widening of Bunker Hill Road Houston, Texas

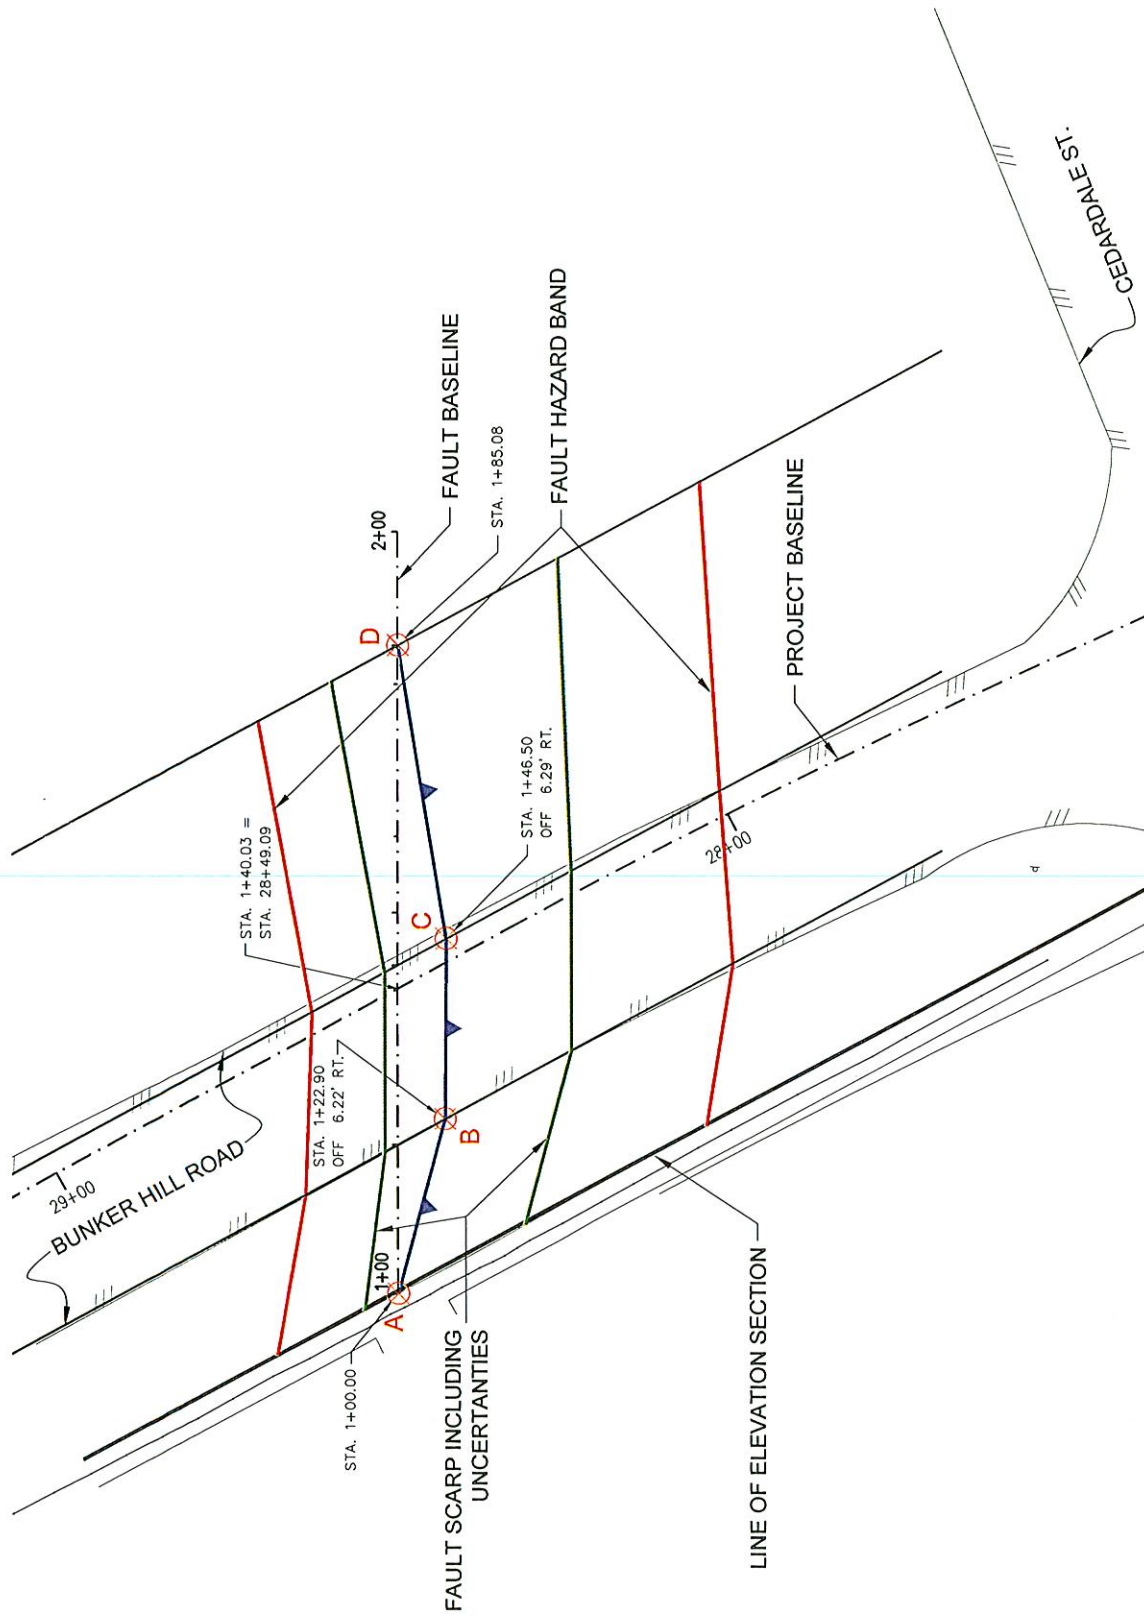
FAULT LOCATION PLAN
LONG POINT FAULT AT BUNKER HILL ROAD
LOCKWOOD, ANDREWS & NEWMAM, INC.
HOUSTON, TEXAS

- 2 There is also a highly visible fault scarp in Bunker Hill Road, but it is much wider than the scarp in the sidewalk, because it has been “feathered” over a substantial distance, perhaps 20 ft to the north and 100 ft to the south of the fault, by previous work on the street. From Point A, the crest of the fault passes eastward across the pavement of Bunker Hill, where the pavement shows some minor cracking from either movement of the fault or from reflection of fault-induced cracks in the underlying older pavement. The surface cracks extend across perhaps half of the width of the pavement, are open less than about 1/16 in., and show little vertical offset at or within 6 in. of the crack. Despite the subtle nature of the cracks, we consider it highly likely that they represent the crestal cracks of the fault, so I marked them at the edges of the pavement as Points B and C for recovery by the surveyor. The locations of both are shown in the plan on Plate 1.

We have drawn a bold line on Plate 1 as our interpretation of the approximate location of the principal shear of the fault, as defined by Points A through D. The filled triangles on the line point to the downthrown side of the fault.

The locations of the fault, its deformation zone, and a recommended fault hazard band are shown in the plan on Plate 1. The coordinates of the points that define the scarp and a recommended fault hazard band are listed in the table on Page 5 with respect to the fault baseline shown on Plate 1.

Siting and Design Considerations. We consider it likely that virtually all of the deformations caused by the fault will take place within the interpreted deformation zone. We recommend that the fault deformation zone be treated as an area where there is a risk of concentrated surface deformations caused by the fault. We recommend that the utilities be designed considering the possible movements of the fault, both horizontal and vertical, as described below in the section on "Fault Activity".

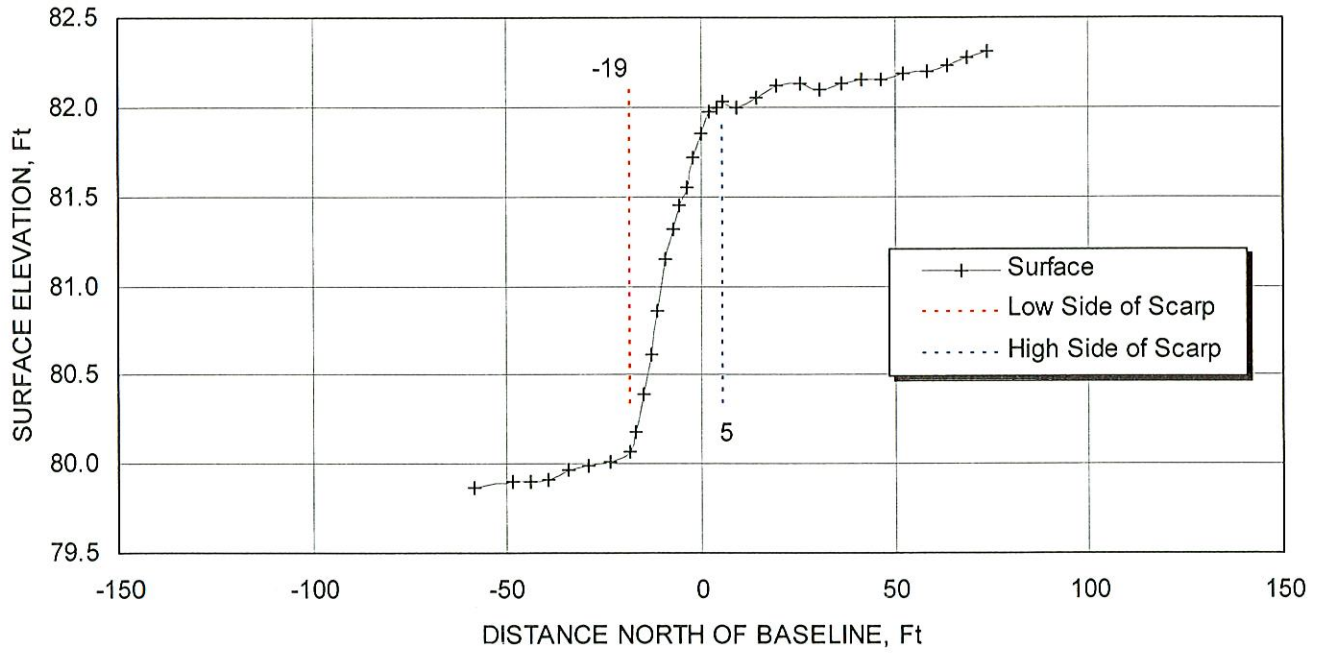
ELEVATION SECTION ALONG SIDEWALK

- 1 There is a sharp, highly visible fault scarp in the concrete sidewalk on the west side of Bunker Hill. Although some parts of the sidewalk at the fault have been replaced, the sidewalk on each side of the fault is obviously much older, and it appears that the sidewalk comes very close to a true representation of the shape and width of the deformations caused by the fault. I set Point A on the largest crack in the sidewalk, which I interpreted at the time to be the principal crest crack caused by the fault (See Plate 1). Point A is the beginning (zero) point on an elevation section that runs across the fault, along the center of the sidewalk.

We interpreted the fault scarp from the elevation section on Plate 2. At that location, the interpreted fault scarp is about 1.9 ft high and 24 ft wide along the line of section and about 18 ft wide perpendicular to the fault trace. We extrapolated the interpreted scarp to the other three points where the fault was located. To further account for questions about possible differences in the width of the fault scarp in the curve, we added 4 ft of uncertainty on the north side at the two middle points. We also included the estimated 5-ft uncertainties in locating the fault at the point on the east right of way line. Coordinates of the scarp (with uncertainties), the recommended fault hazard band, and the approximate location of the principal shear are listed in the table below.
